Plate 4 details primary friction zones.

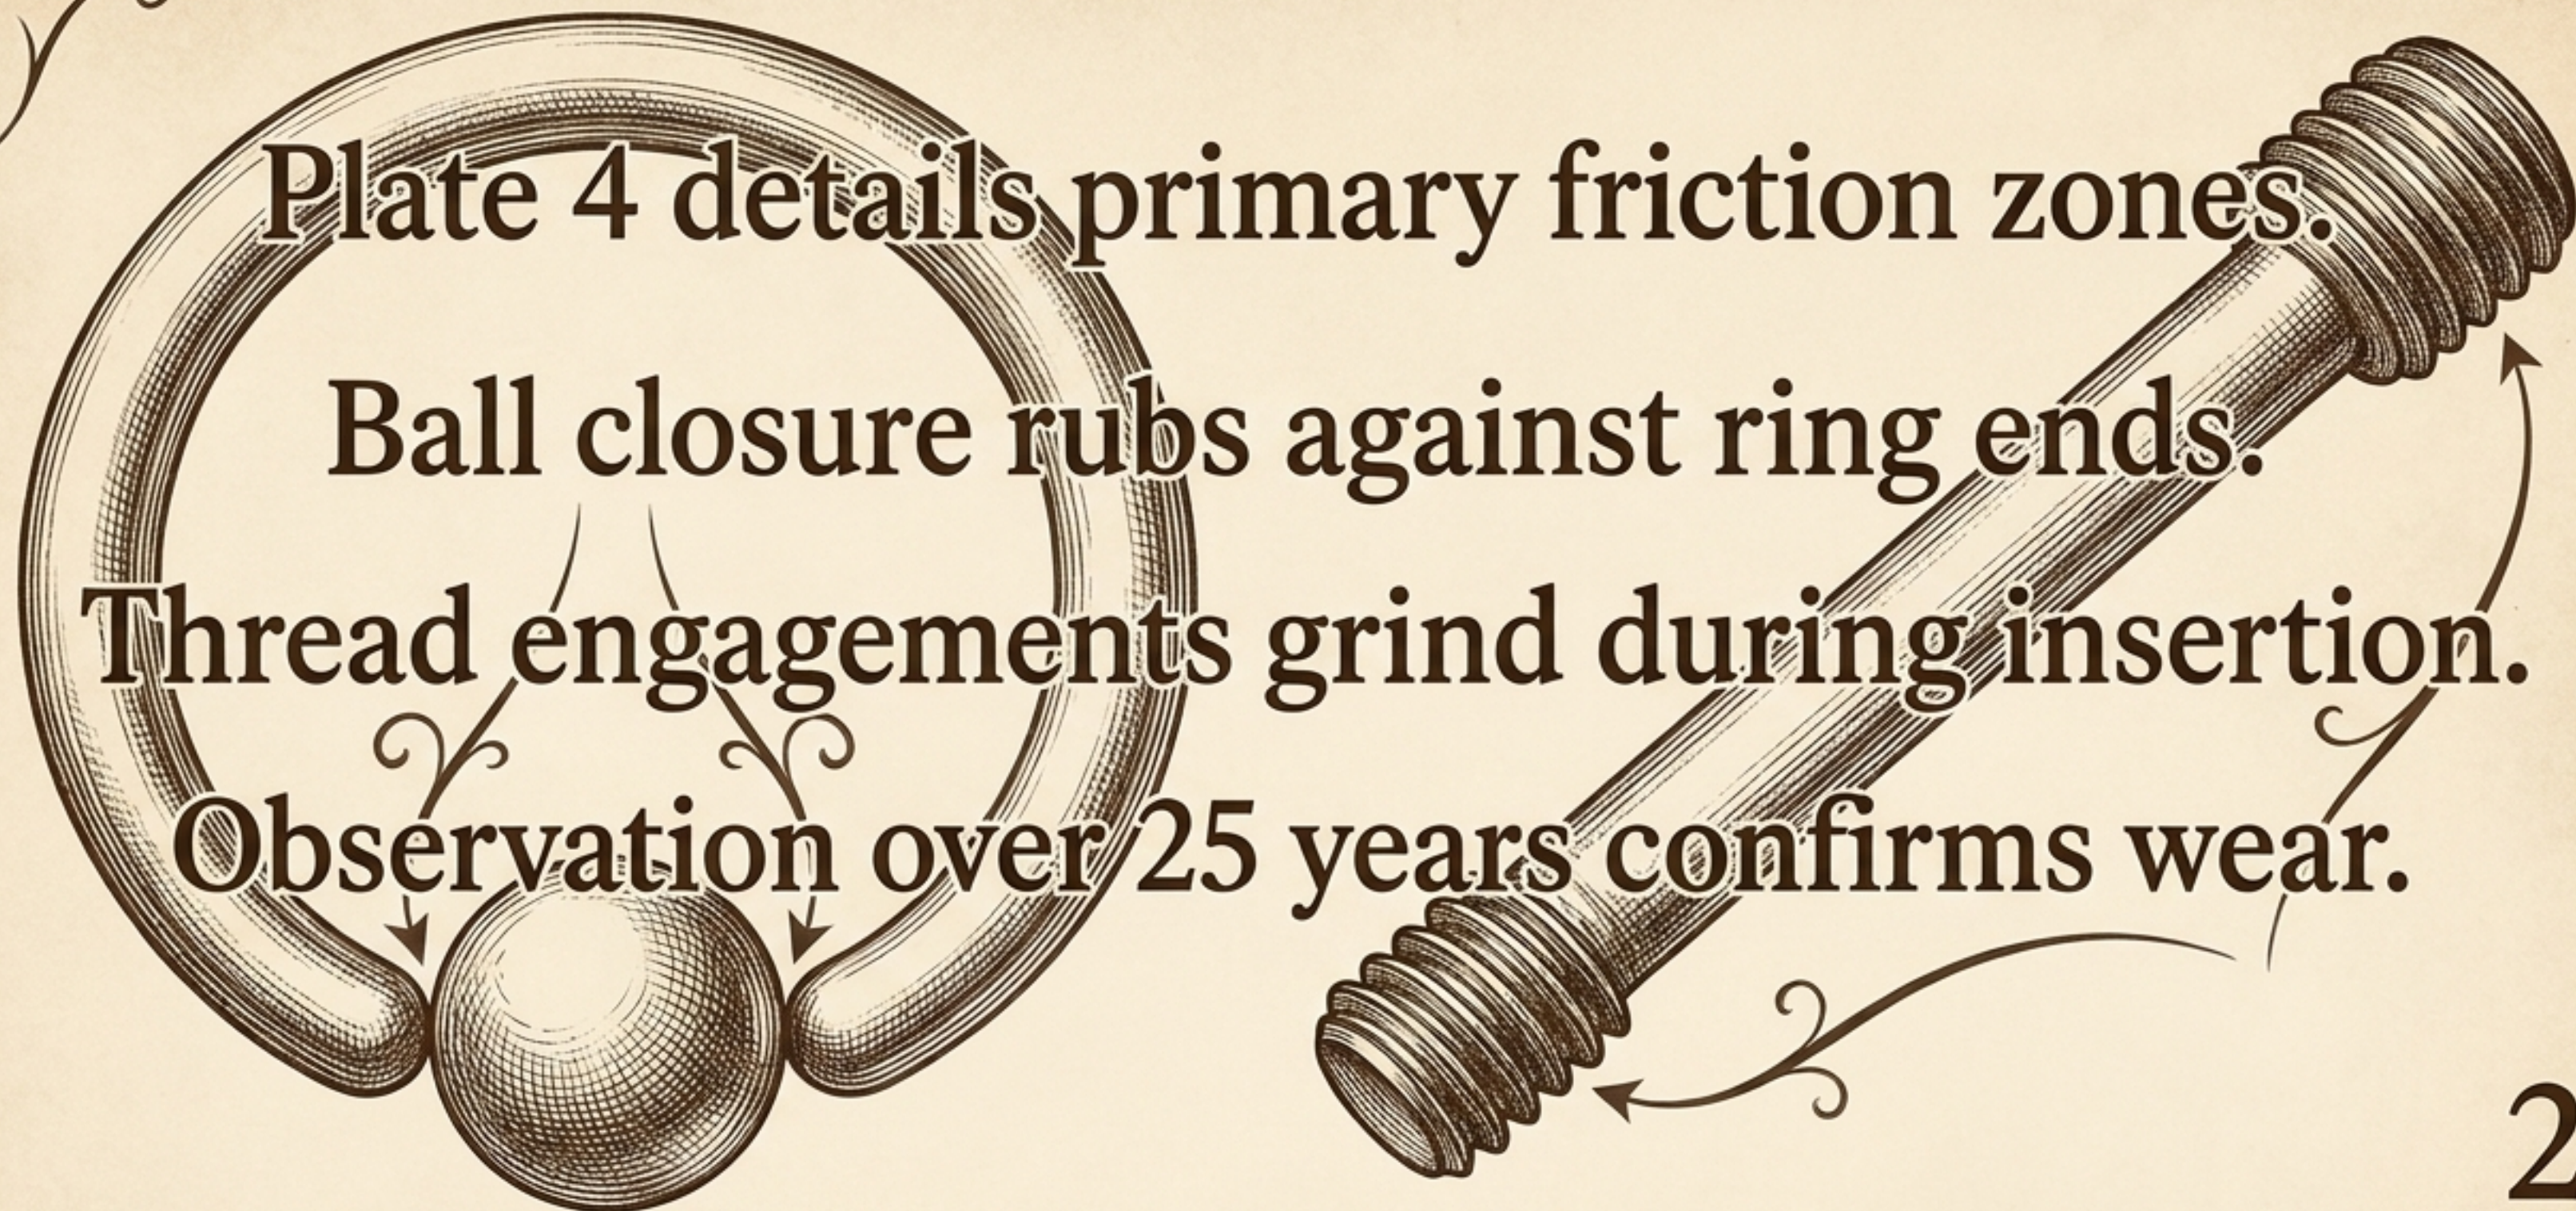
4

Ball closure rubs against ring ends.

Thread engagements grind during insertion.

Observation over 25 years confirms wear.

Daily contact and movement cause friction at jewellery closures.  
Scratched titanium dioxide repairs itself.
