**NEVER SAFE FOR ANY PIERCING**

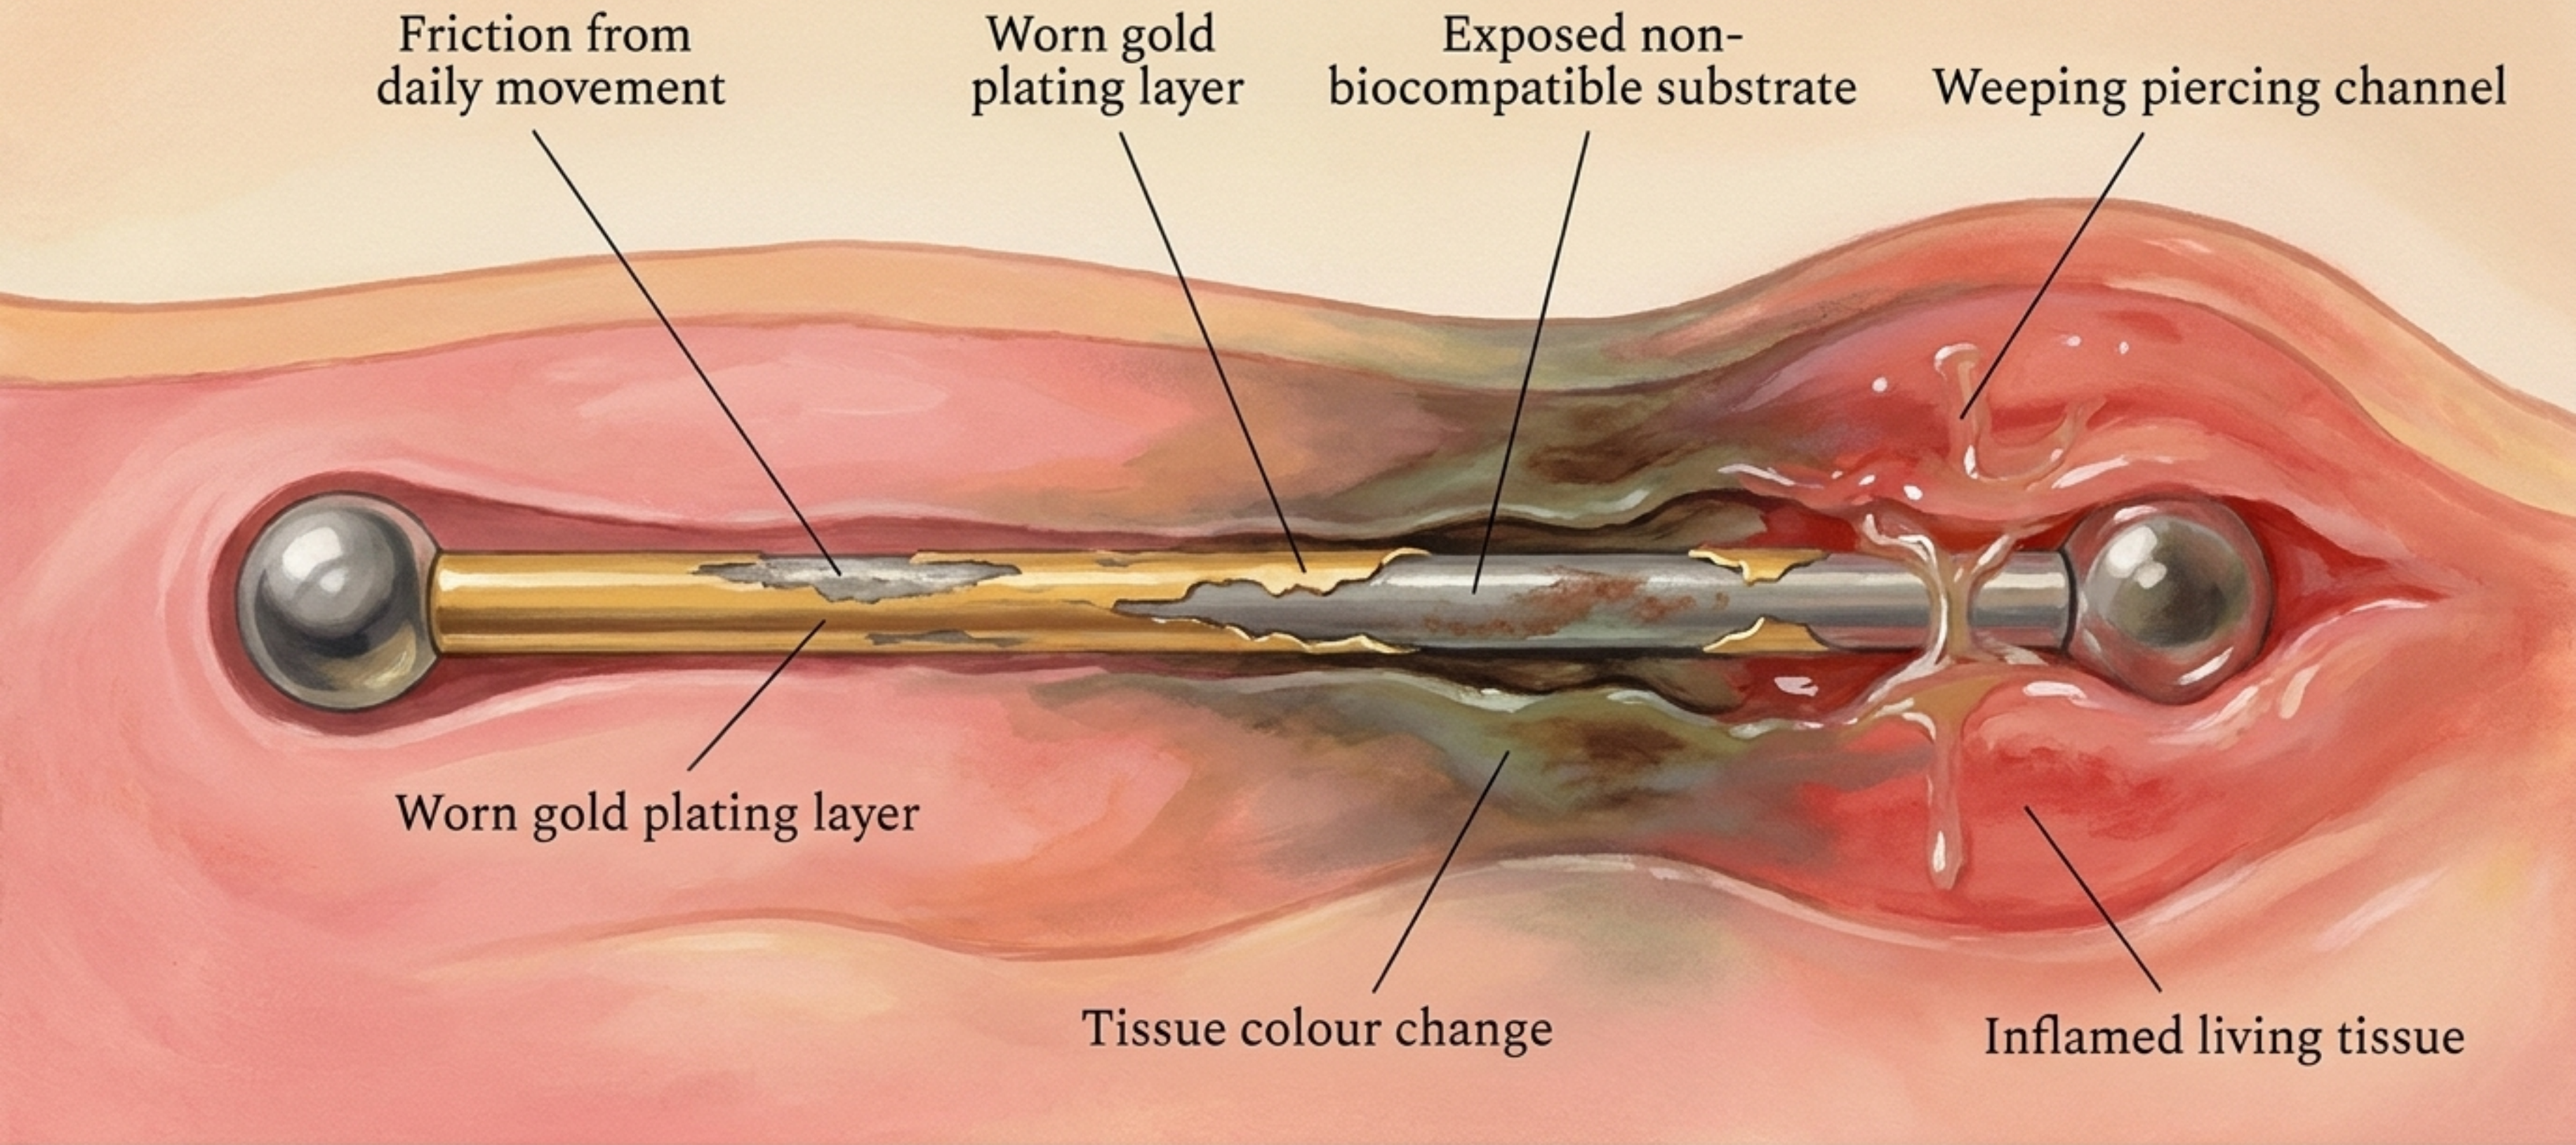
Friction from  
daily movement

Worn gold  
plating layer

Exposed non-  
biocompatible substrate

Weeping piercing channel

Tissue colour change

Inflamed living tissue

*Microns-thick plating inevitably fails from friction and exposes reactive substrates directly to healing tissue.*
